Analysis of Equipment Storage Area Facility Provision to Create Safety Flow for Ground Support Equipment (GSE) at Sultan Aji Muhammad Sulaiman Sepinggan Balikpapan International Airport

Thufail Rizqi Nur Hilal^{*}, Elfi Amir, Dian Anggraini Purwaningtyas
Airport Operation Study Program, Indonesia Aviation Polytechnic Curug, Indonesia

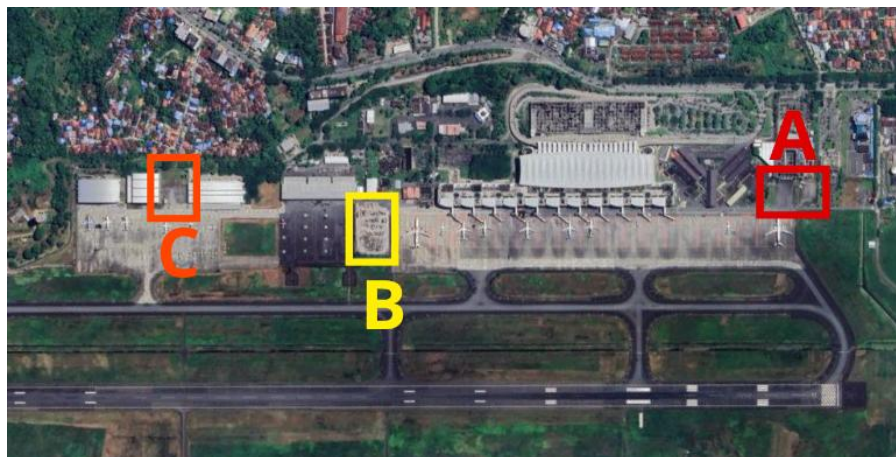
Figure 1 SAMS Sepinggan Airport Ground Support Equipment Layout[3]

Sultan Aji Muhammad Sulaiman Sepinggan Airport maintains three Equipment Storage Areas (ESA) to support GSE availability: Alpha storage (adjacent to the old terminal), Bravo storage (between main apron and helicopter apron), and Charlie storage (between cargo terminal and Charlie hangar).

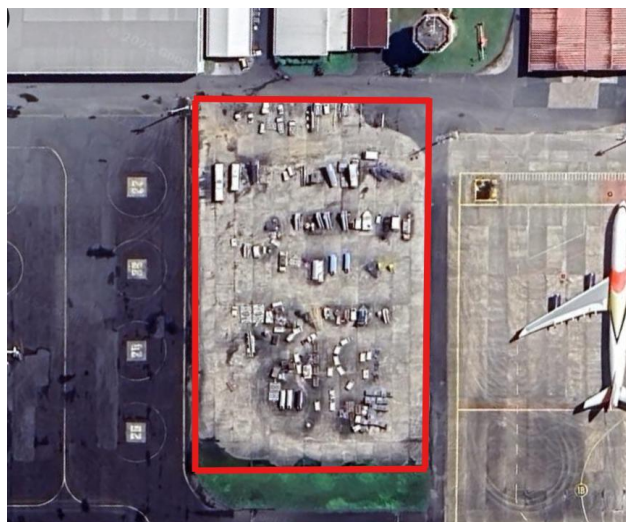
Figure 2 Equipment Storage Area B Location [3]

Direct observations conducted at the Equipment Storage Areas revealed that conditions at Storage B do not meet operational safety standards established by aviation regulations. As shown in figures 2, it was found that the condition of Storage B does not yet have equipment storage markings, resulting in untidy GSE placement.

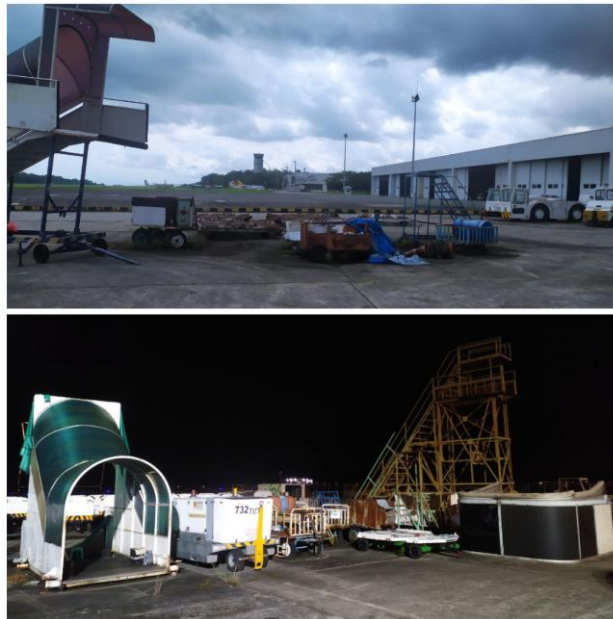
Figure 4 Storage B Condition

After observing the equipment storage area, it was found that the placement of Ground Support Equipment (GSE) in Storage B was not neatly arranged and obstructed the flow of other GSE. This is due to the lack of equipment storage markings that would indicate the boundaries of the storage area. This is regulated by the Decision of the Director General of Air Transportation No. PR 21 Year 2023 concerning Technical and Operational Standards of Civil Aviation Safety Regulations - Part 139 (Manual of Standard CASR - Part 139) Volume I Aerodrome. In response, the airport, specifically the Apron Movement Control (AMC) unit, has advised ground handling personnel to store and monitor their respective GSE to avoid disrupting other GSE operations.

Based on the observations conducted by the researcher, the efforts expected to be carried out involve improving the storage area by repairing the surface structure and adding equipment storage markings. This will allow GSE service operations and placement to be implemented regularly, and the storage area to be used efficiently, orderly, and safely. The available storage areas are A, located east of the Terminal; B, situated between the main apron and the heli apron; and C, positioned between the Cargo Terminal and the Hangar. In Storage B, it was found that the placement of GSE was not neatly arranged and obstructed the movement flow of other GSE, due to the absence of equipment storage markings. These conditions can disrupt flight operations by hindering services and reducing safety and security levels. The uneven and undulating surface condition of the storage area, along with the untidy and unorganized placement of Ground Support Equipment (GSE), can increase the risk of disturbances to operational safety, security, and smoothness.

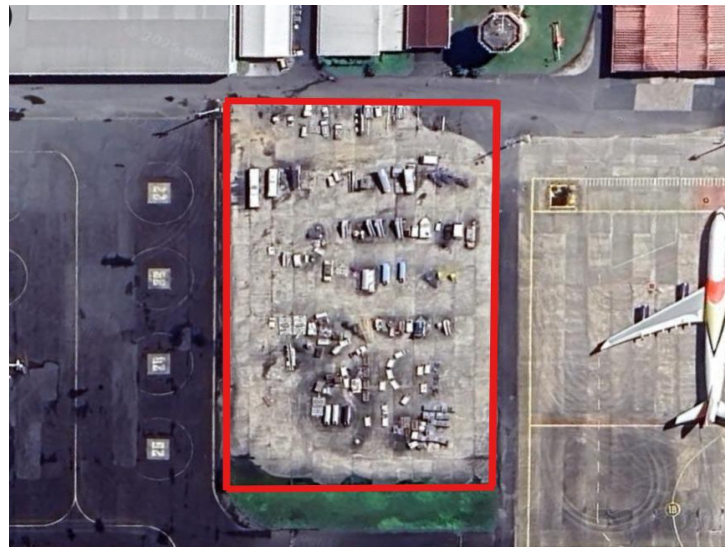
Figure 5 Storage B Condition [3]

The author's observations indicate that the placement of Ground Support Equipment (GSE) in Storage B still does not meet ideal operational order and safety standards. The primary factor causing this condition is the absence of equipment storage markings, which serve as clear boundary indicators for the GSE storage area. Markings play a very important function in aviation operations. The lack of markings leads to disorderly and irregular GSE placement, with some GSE even obstructing the traffic flow of other GSE. This condition not only complicates operator access to specific GSE but also creates the potential for incidents and service disruptions.

Referring to the Decision of the Director General of Air Transportation No. PR 21 Year 2023 concerning Technical and Operational Standards of Civil Aviation Safety Regulations Part 139, markings for equipment storage should be:

1. In the form of a single line with a width of 0.1 meter.
2. Equipped with the words "EQUIPMENT STORAGE" in red with a font size of 0.3 meters and a distance of 0.15 meters from the line, with writing repetition intervals of no more than 50 meters along the boundary line.

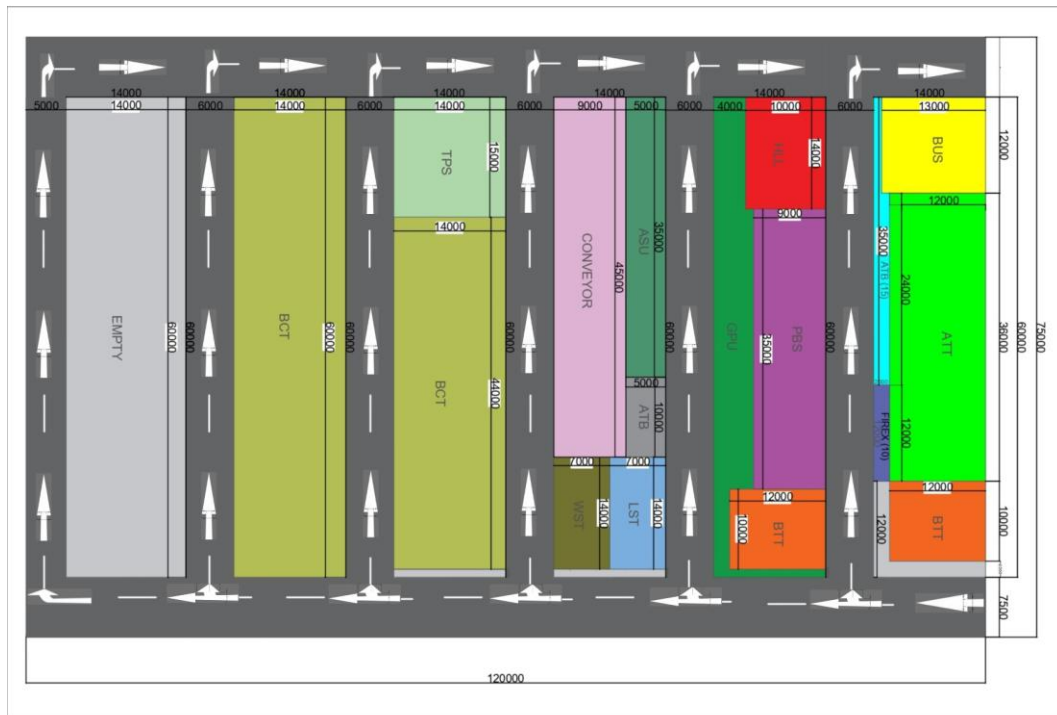
Figure 7 Layout of GSE Placement

The flow of Ground Support Equipment (GSE) in and out of the storage area is carefully designed to ensure smooth operations. This process begins with the GSE access point, which must always be free of obstacles and have sufficient width to allow large vehicles to pass through easily, serving as the main gateway for all GSE before entering the storage area. Inside Storage B, the arrangement of GSE is highly strategic, based on the frequency of its use during daily operations, meaning that the most frequently used GSE is placed in easily accessible locations. Meanwhile, the empty area at the back of the storage can be flexibly utilized, either as a temporary repair area or a location for placing damaged GSE, with the primary objective of optimizing Equipment Storage B as an efficient main storage area throughout flight operations. Once the GSE is ready for use, access from the storage area to the service road and apron must be direct and aligned with the direction of assignment, always free of obstacles, and if necessary to ensure safety, supervisory personnel will escort the movement of the GSE until it reaches the apron area. The entire design flow and layout are clearly reflected in the detailed layout plan for the Equipment Storage Area (ESA) provided.

The diagram visually maps the arrangement of various types of Ground Support Equipment (GSE) at the airport, displayed with dimensions in millimeters. The layout divides the storage area into several segments identified by specific colors and labels, such as EMPTY, BCT, TPS, CONVEYOR, ASU, GPU, PBS, ATB, LST, WST, FIREX, BTT, ATT, and BUS, each marking the specific location of certain GSE. Thick white arrows scattered throughout the layout clearly indicate the designated movement directions for GSE, ensuring safe movement flow and preventing congestion, while the dimensions listed on each segment guarantee sufficient space for parking and maneuvering. Thus, overall, this design aims to optimize space utilization, enhance operational efficiency, and, most importantly, create a safe movement flow within the equipment storage area.

The implementation of markings should also be complemented by a GSE layout that considers equipment traffic, the position of access and exit to the apron. Thus, the management of the Equipment Storage Area (ESA) will be more safety, efficient, and meet the applicable regulatory standards. The following layout is made by the researcher as a suggestion for GSE layout in storage B at Sultan Aji Muhammad Sulaiman Sepinggán Balikpapan International Airport :
